# Manhole Inspection Summary

Manhole # S27C\_\_007MH

Insp Date: **12/3/07 1:44 PM**

**Location** Address: **960 FRANKLIN ST**

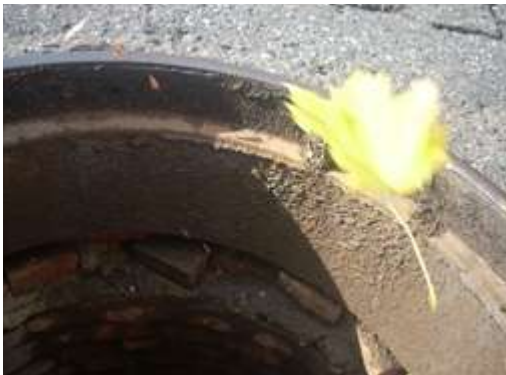
Defect 4

Condition: ☐ Sound ☐ Cracked ☐ Root Intrusion ☐ Loose Brick ☒ **Deteriorated**

CHIMNEY DETERIORATION

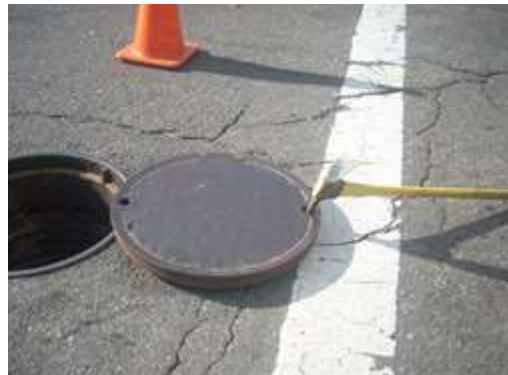
Defect 1

Condition: **Worn**

WORN COVER

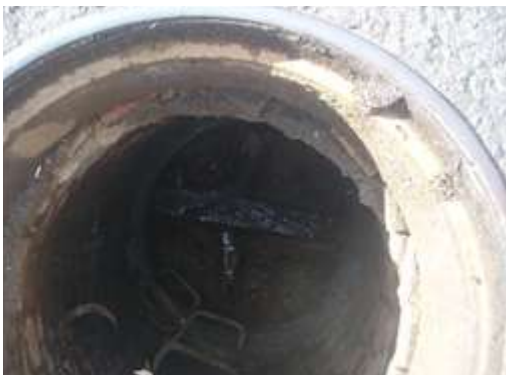
Defect 3

Offset: **2** (in.)

FRAME OFFSET

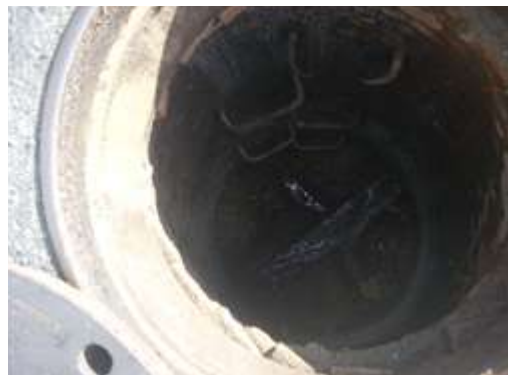
Defect 2

Count: **4** Missing: **1** ☒ **Corroded**

MISSING AND CORRODED STEPS

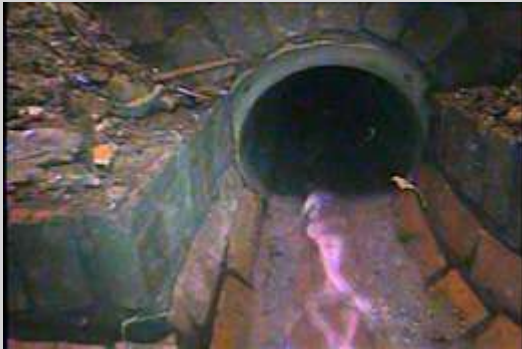
12 O'Clock Outflow

10 in. Circular Gravity Sewer  
Pipe Out @ 12 O'Clock

Pipe Height: **9.6** (in.) Rod and Bar (Angled)  
Pipe Material: **Clay** ☐ Pipe Lined  
Invert Depth: **10.60** (ft.) Flow Characteristics: **Slow**  
Deposits: ☒ None ☐ Mud ☐ Sludge ☐ Debris ☐ Grease  
Silt Depth: (in.) Deposits Extent:  
Infiltration: **None** Pipe Seal Cond: **Sound**

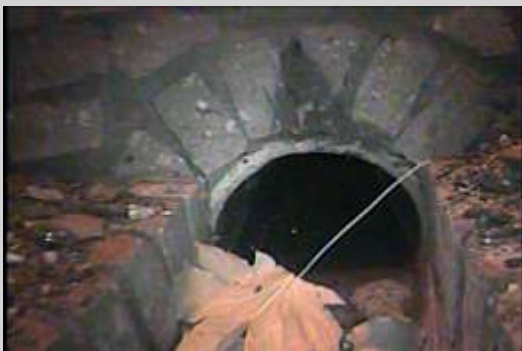
3 O'Clock Inflow

8 in. Circular Gravity Sewer  
Pipe In @ 3 O'Clock

Pipe Height: **8.4** (in.) Rod and Bar (Angled)  
Pipe Material: **Clay** ☐ Pipe Lined  
Invert Depth: **10.40** (ft.) Flow Characteristics: **Slow**  
Deposits: ☐ None ☐ Mud ☐ Sludge ☒ **Debris** ☐ Grease  
Silt Depth: **2** (in.) Deposits Extent: **Light**  
Infiltration: **None** Pipe Seal Cond: **Sound**

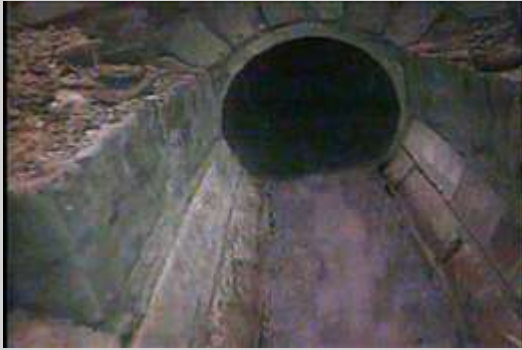
6 O'Clock Inflow

Pipe Height: **10.8** (in.) Rod and Bar (Angled)

Deposits: ☒ None ☐ Mud ☐ Sludge ☐ Debris ☐ Grease

Infiltration: **None** Pipe Seal Cond: **Sound**

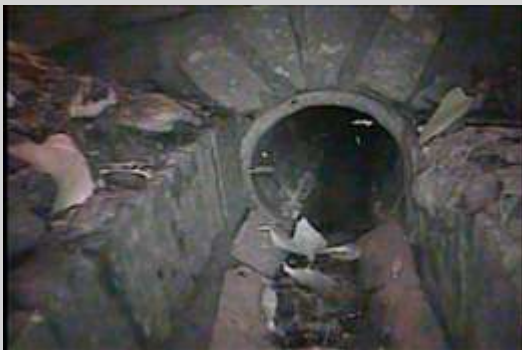
9 O'Clock Inflow

Pipe Height: **6** (in.) Rod and Bar (Angled)

Deposits: ☒ None ☐ Mud ☐ Sludge ☐ Debris ☐ Grease

Infiltration: **None** Pipe Seal Cond: **Sound**

Connects To: **Dead End**
